Idlewild Riverfront Condominium Association

Full Reserve Study

Start Date: 01/01/2017

Better Reserve Consultants

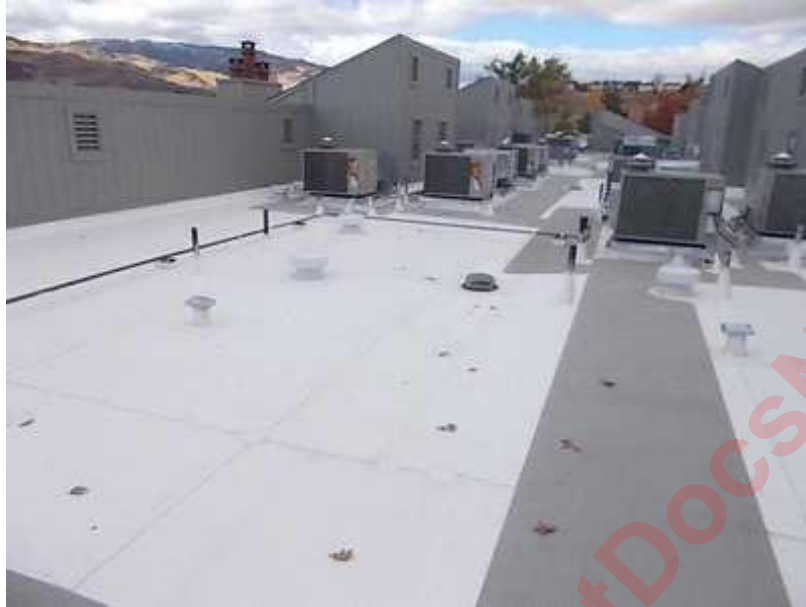
The Roof Replacement Schedule was provided by Scotts Roofing, Reno, Nevada. Each Individual Owner has their own HVAC System. These units are not maintained by the HOA.

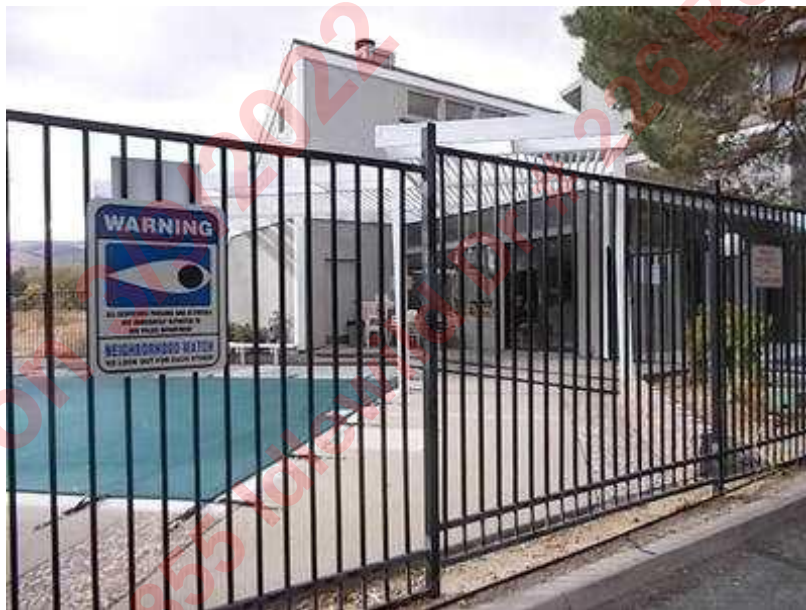
The Wrought Iron Fencing is Painted by the Maintenance Supervisor through the Operating Budget.

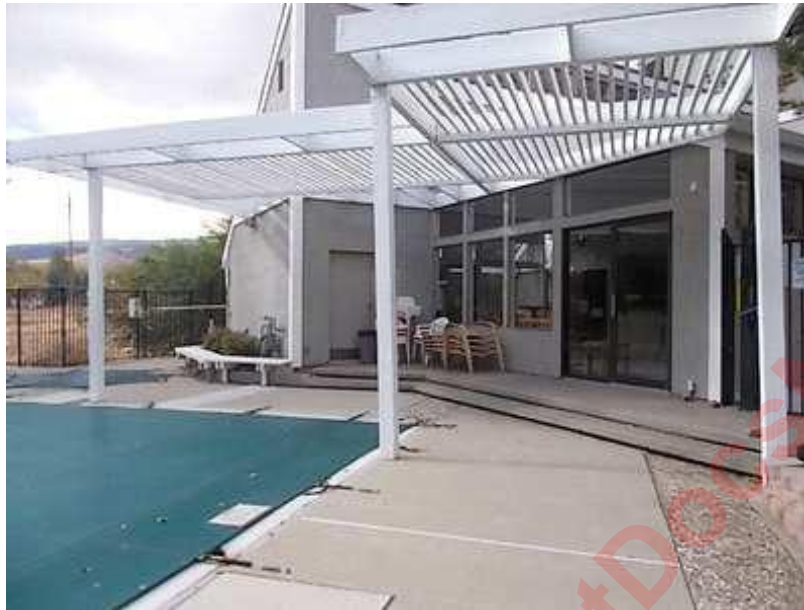
The Shade Structure is Painted and Repaired through the Operating Budget. Future Replacement of the Trellis has been included in the Study.

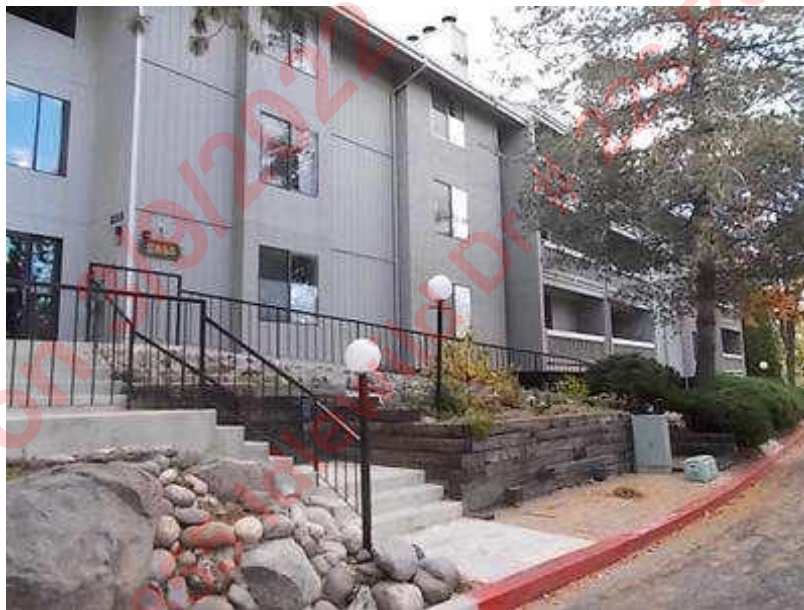
The Building Exterior Category includes Exterior Painting, Roof Replacement, Building Lighting, Entrance Doors, Common Area Windows, and Deck Structural Repairs.

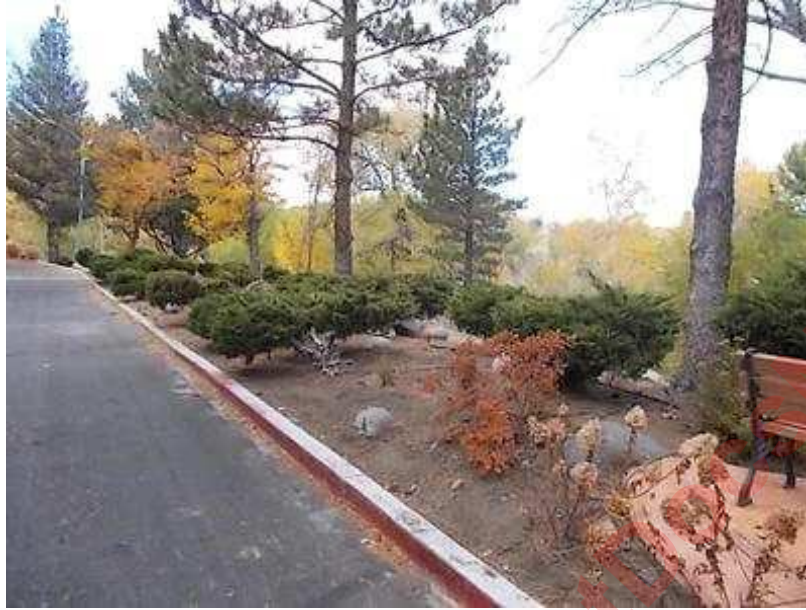
The Component Major Landscaping and Irrigation includes: Tree and Bush Removal and Replacement, Major Irrigation Repairs, Rock or Landscaping Renovation to be done as needed. Day-to-day Landscaping is considered an Operational Expense and has not been included in this Study.

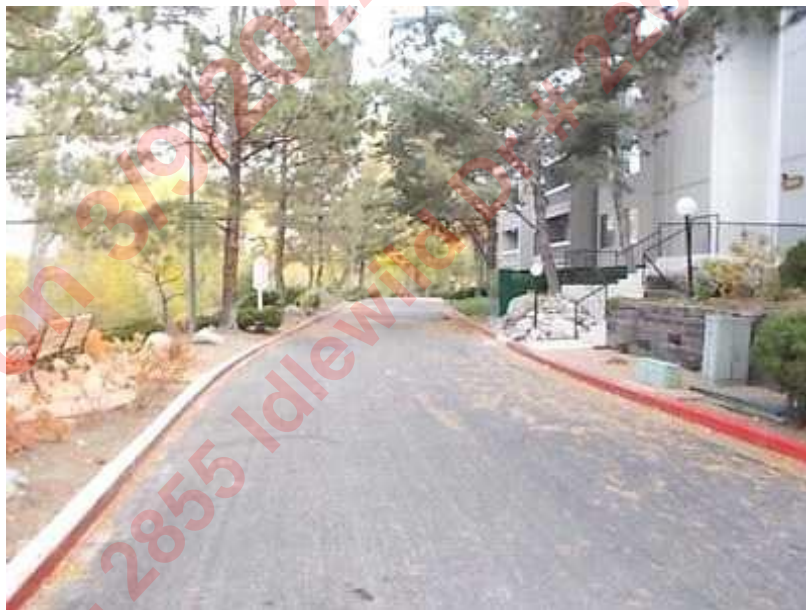
The Asphalt Road Maintenance Schedule includes the Surface Maintenance Treatment, Overlay, Crack Seal, Concrete Curbing Repairs and Striping and Curb Painting. This Schedule is an estimation only.

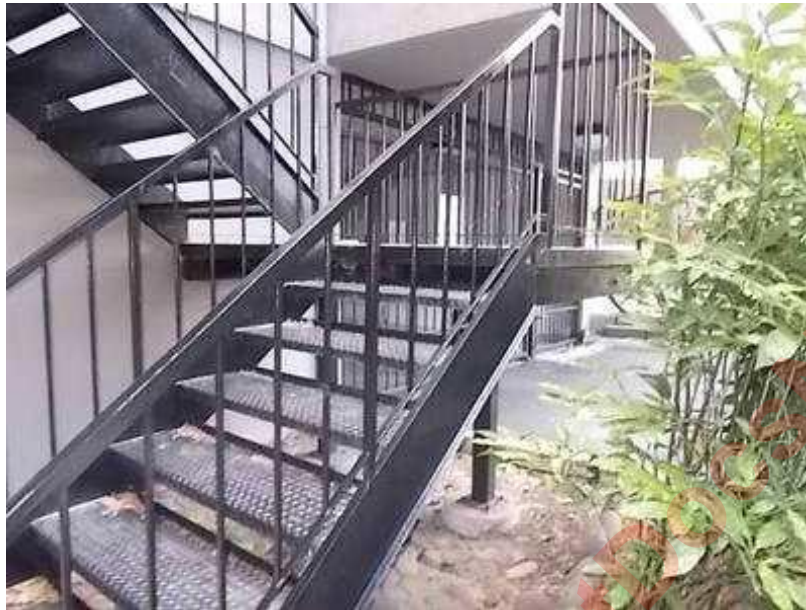
The Metal Stairway Replacement has been included in the Study. The Stairways are Painted by the Maintenance Supervisor and included in the Operating Budget.

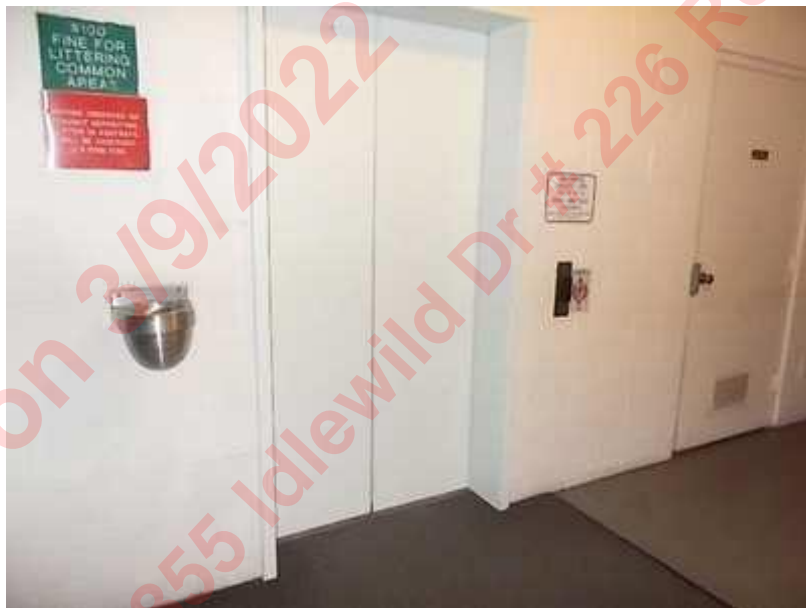
The Elevator Modernization Useful Life was obtained by Koch Elevators, Reno, Nevada.

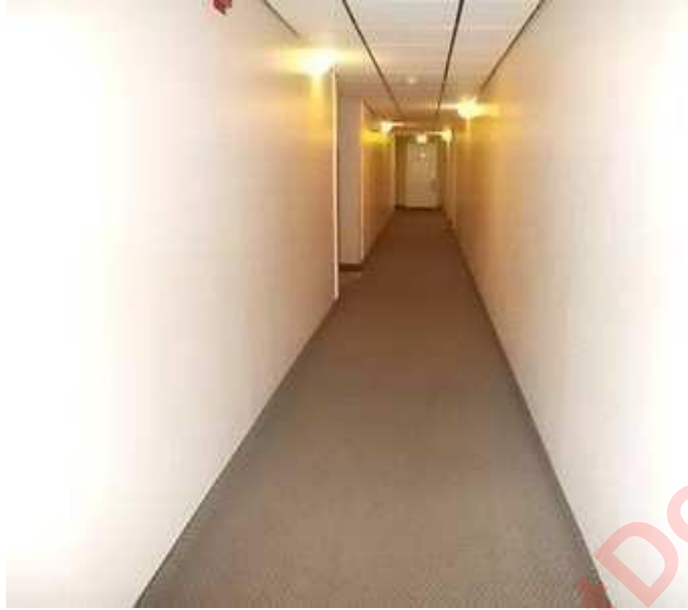
The Interior Hallway Painting is done by the Maintenance Supervisor. However, this cost has been included in the Study in case an outside company is chosen to perform the work. Exit Lighting was replaced in 2016 and is considered a Reserve Expense. Ceiling Tiles are Replaced as needed through the Operating Budget. Hallway Carpet Replacement is considered a Reserve Expense and has been included in the Study.

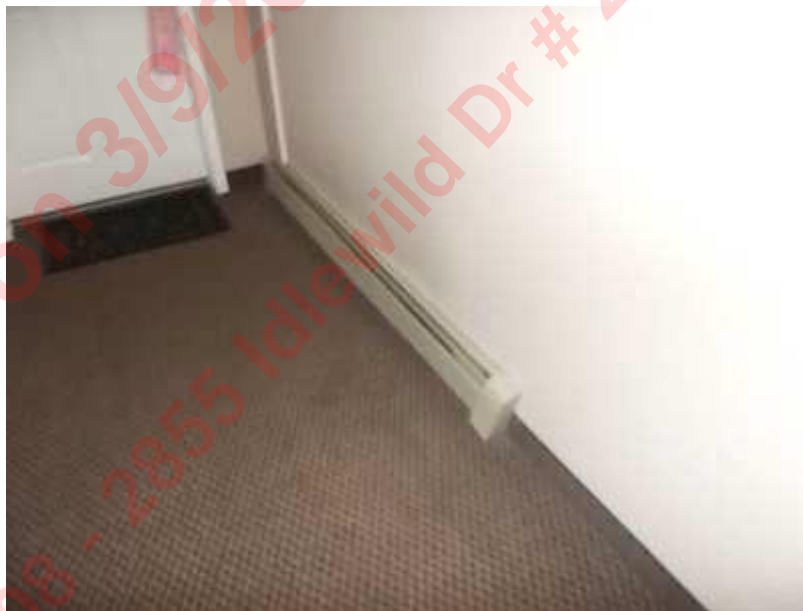
There are Electric Baseboard Heaters on each floor in the Hallway. Future Replacement of these units has been included in the Study.

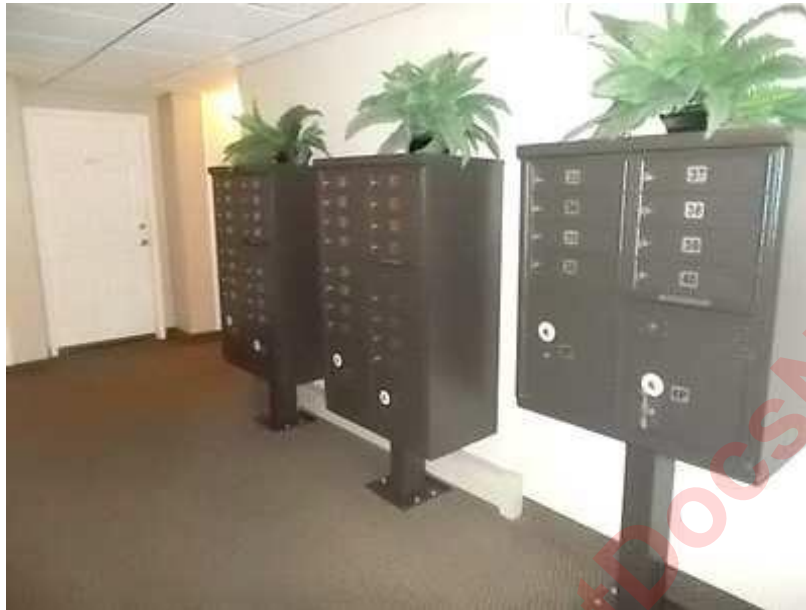
The Mail Boxes are Maintained by the Homeowners Association. The Estimated Useful Life when New is approximately 20 years. Replacement has been included in this Study.

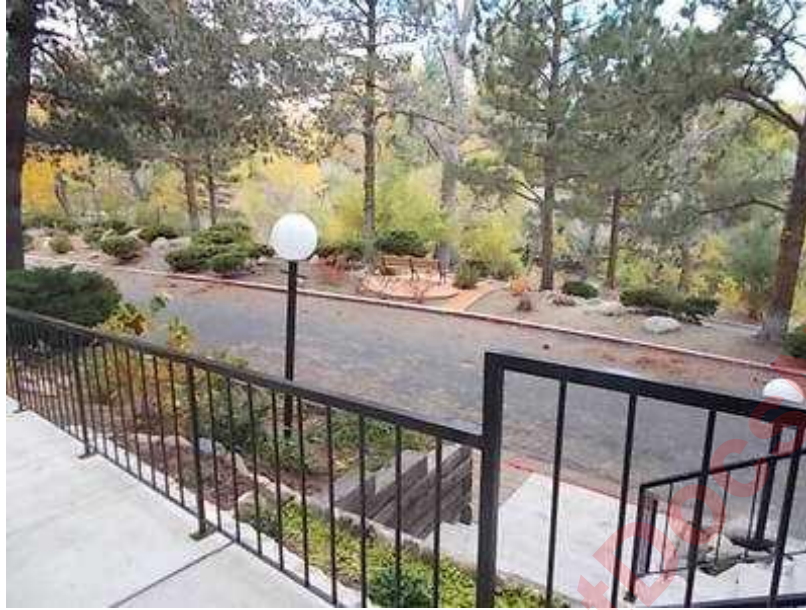
Painting of all Wrought Iron is done by the Maintenance Supervisor every 5 years or when needed. Future Replacement of the Pole Light Fixtures has been included in the Study.

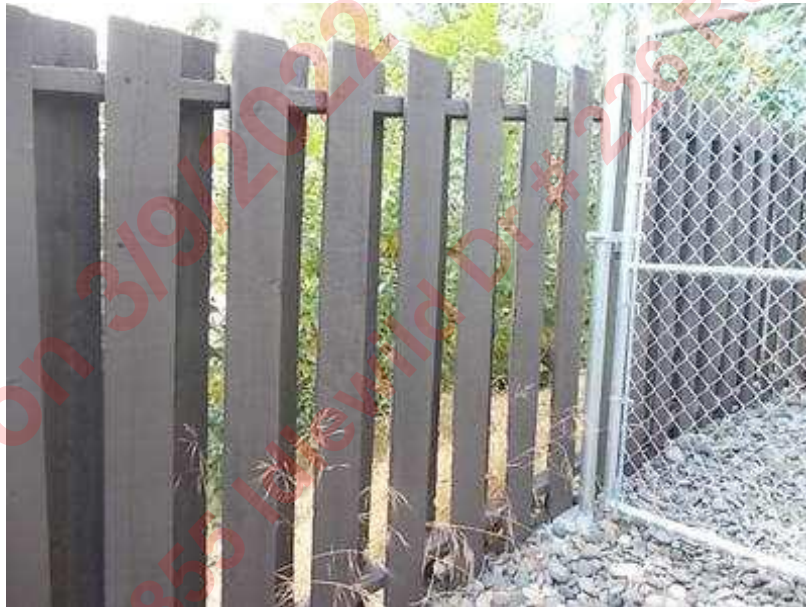
Repair and Painting of the Perimeter Wood Fence is done by the Maintenance Supervisor. This is a "good neighbor fence" shared with the adjacent property.

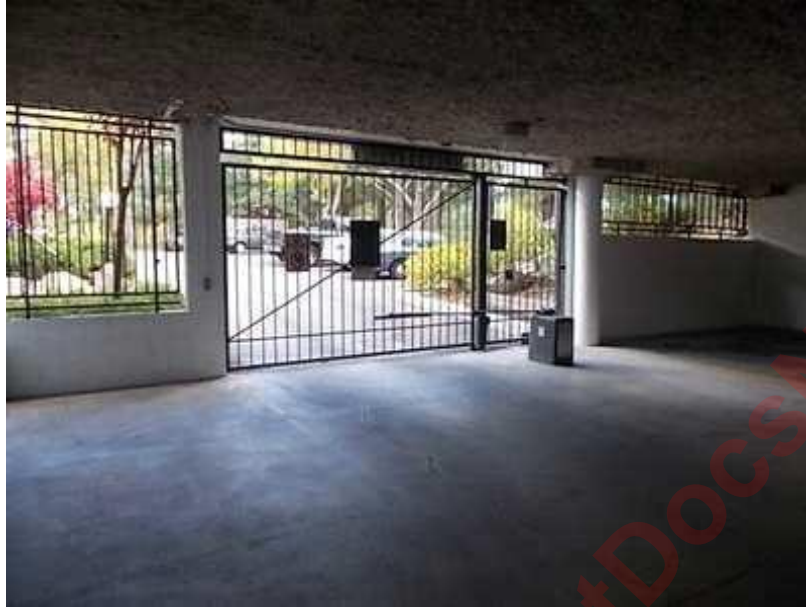
The Garage Entrance Components include the Gate and Gate Operator. There are 4 Entrance areas.

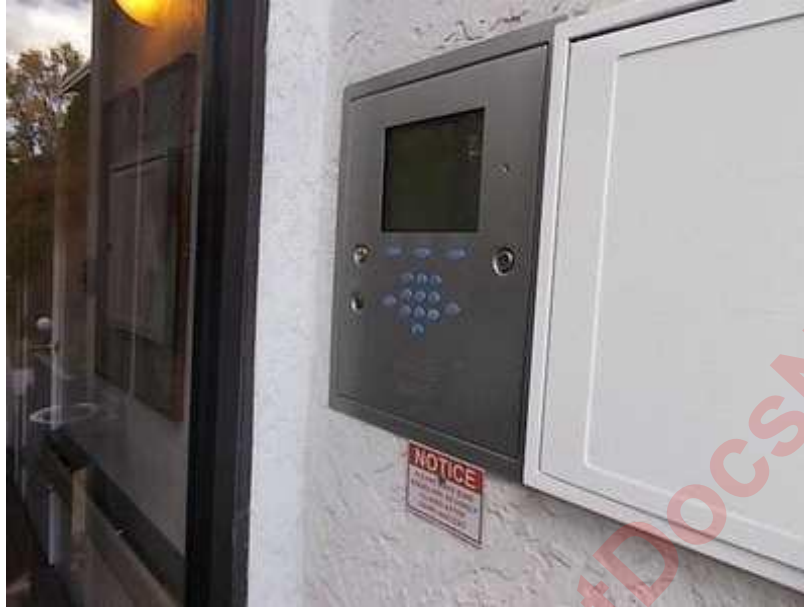
The Security Entrance System and Key Fob System information was provided from the Vendor.

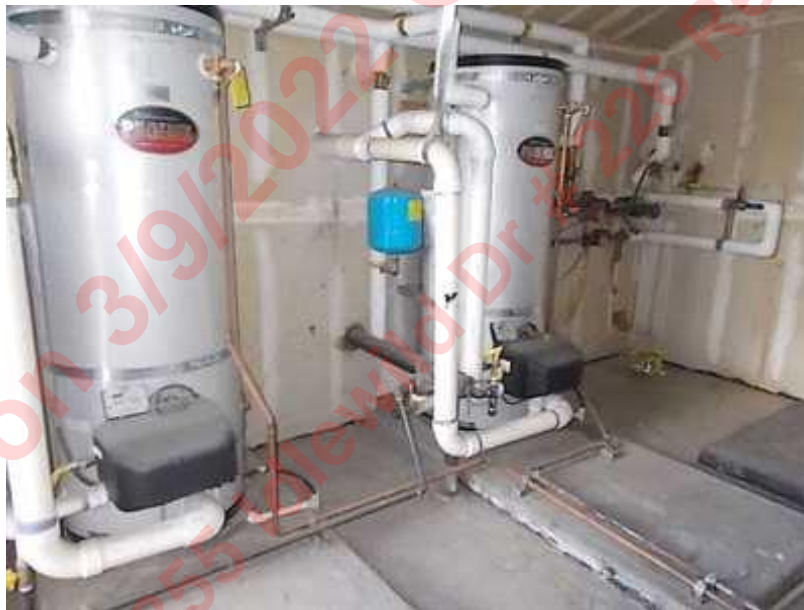
The 2 Water Heaters are located in Building 2855. These Units were installed in 2008 and have an Estimated Useful Life When New of 12-15 Years. Future Replacement has been included in the Study. The Replacement Cost and Estimated Useful Life was provided by Carl Michael Chinnici, Aardvark Mechanical, Reno, Nevada.

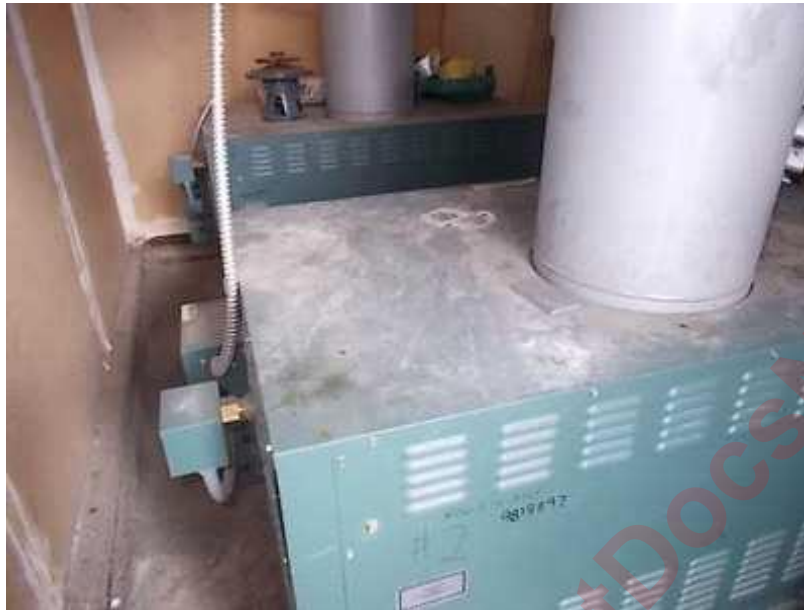
There are 2 Boiler Systems in building 2845. Replacement of the Boilers and Future Maintenance Costs were provided by Carl Michael Chinnici, Aardvark Mechanical, Reno, Nevada.

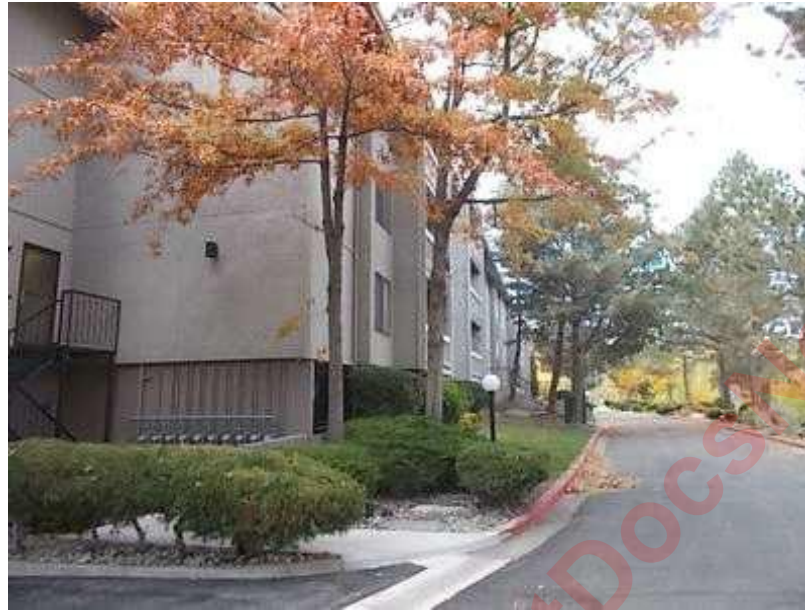
Component	Year Scheduled	Units	Cost Per Unit	Today's Cost	Estimated Remaining Useful Life (Years)	Estimated Life When New (Years)
Building Exterior - Decks Railings Replacement (Done 2016)	2036	as needed	500.00	42000.00	19	20
Building Exterior - Decks Structural Repairs or Replacement	2027	84 units	2000.00/unit	168000.00	10	30
Building Exterior - Gutter Replacement	2018	as needed	7500.00	15000.00	1	10
Building Exterior - Lighting	2022	2 units	2500.00/unit	5000.00	5	10
Building Exterior - Painting and Repairs	2019	all	1500.00	126000.00	2	7
Building Exterior - Roof - Asphalt Shingle Replacement	2032	2 building	50000.00/building	100000.00	15	30
Building Exterior - Roof - Flat Elastomeric Roof Replacement	2025	2 building	25000.00/building	50000.00	8	10
Building Exterior - Roof Repairs	2020	2 building	2500.00/building	5000.00	3	5
Building Exterior - Stairway Replacement (Metal)	2017	as needed	8000.00	32000.00	0	20

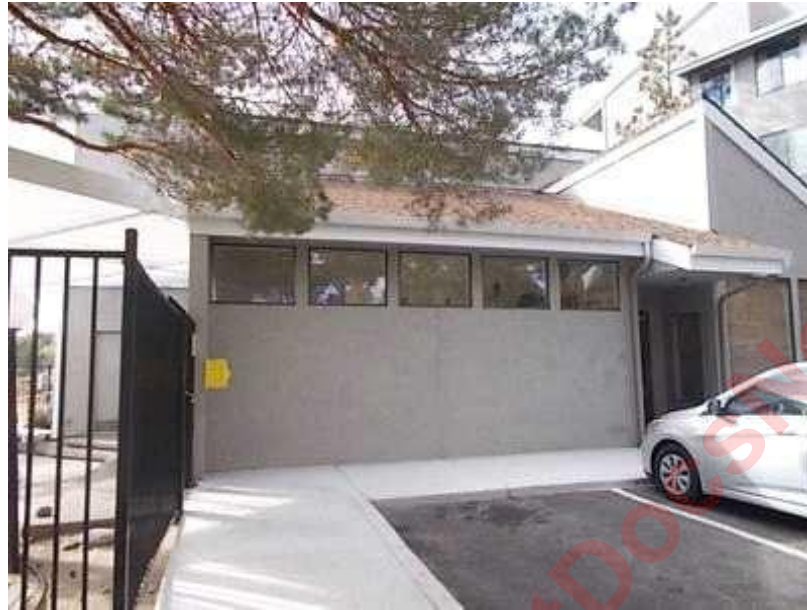
Component	Year Scheduled	Units	Cost Per Unit	Today's Cost	Estimated Remaining Useful Life (Years)	Estimated Life When New (Years)
Clubhouse - Electrical System and Lighting	2026	as needed	1500.00	1500.00	9	10
Clubhouse - Flooring	2018	all	4600.00	4600.00	1	10
Clubhouse - Furniture	2017	as needed	1000.00	1000.00	0	10
Clubhouse - HVAC (Replaced 2016)	2036	1 unit	7500.00	7500.00	19	20
Clubhouse - Kitchen Remodel	2022	as needed	2500.00	2500.00	5	30
Clubhouse - Painting Exterior	2019	1 unit	4500.00	4500.00	2	7
Clubhouse - Painting Interior	2019	1 unit	2500.00	2500.00	2	10
Clubhouse - Restroom Remodel	2022	2 units	1500.00/unit	3000.00	5	20
Clubhouse - Water Heater	2022	1 unit	1500.00	1500.00	5	13
Clubhouse - Windows and Doors Replacement	2027	as needed	6000.00	6000.00	10	30

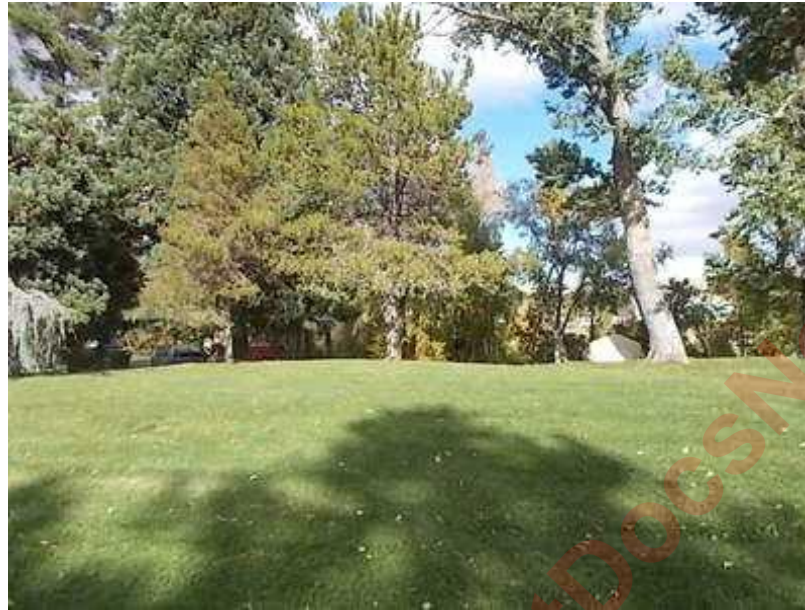
Component	Year Scheduled	Units	Cost Per Unit	Today's Cost	Estimated Remaining Useful Life (Years)	Estimated Life When New (Years)
Common Area - Concrete Repair or Replacement Contingency	2018	as needed	1500.00	1500.00	1	2
Common Area - Fence Perimeter Replacement	2027	650 lf	25.00/lf	16250.00	10	25
Common Area - Fence Wrought Iron, 5400 LF Replacement	2027	all	3500.00	3500.00	10	25
Common Area - Golf Cart	2019	1 unit	7500.00	7500.00	2	7
Common Area - Lights Pole Replacement	2019	all	10000.00	10000.00	2	20
Common Area - Monument Signage Lighting and Electrical Renovation	2022	as needed	1500.00	1500.00	5	10
Common Area - Monument Signage Renovation	2020	1 unit	5000.00	5000.00	3	20
Common Area - Sewer Lift Station	2026	as needed	24000.00	24000.00	9	10
Common Area - Signage Replacement	2021	as needed	1500.00	1500.00	4	5
Common Area - Trash Enclosure Repairs Contingency	2021	as needed	1500.00	1500.00	4	5

Common Area - Utility Line Contingency	2021	as needed	5000.00	5000.00	4	5

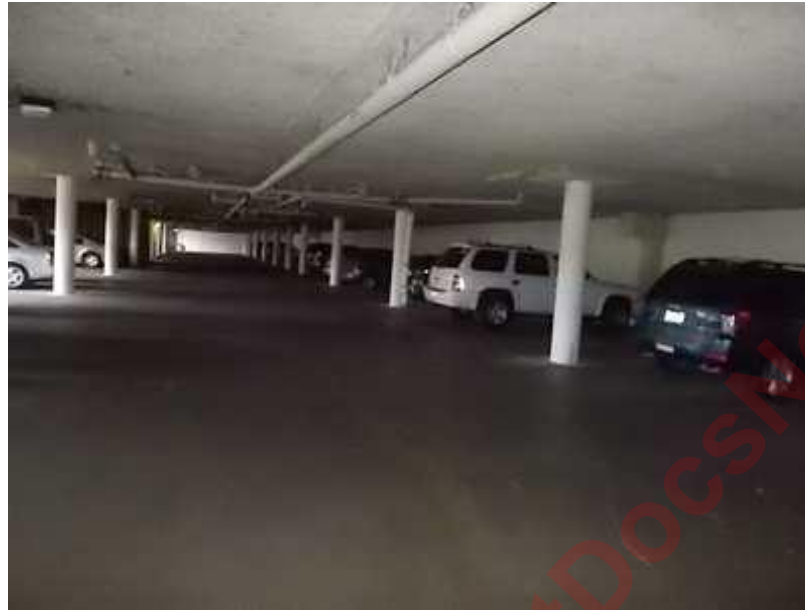
Component	Year Scheduled	Units	Cost Per Unit	Today's Cost	Estimated Remaining Useful Life (Years)	Estimated Life When New (Years)
Parking Garage - Component: Insulation of Piping	2017	as needed	1000.00	2000.00	0	10
Parking Garage - Component: Painting	2022	as needed	1500.00	3000.00	5	15
Parking Garage - Electrical and Lighting	2021	as needed	1500.00	1500.00	4	5
Parking Garage - Gate Motors and Operators	2022	4 units	3500.00/unit	14000.00	5	7
Parking Garage - Gate Replacement	2027	4 units	3500.00/unit	14000.00	10	30
Parking Garage - Painting	2022	2 units	2500.00/unit	5000.00	5	15

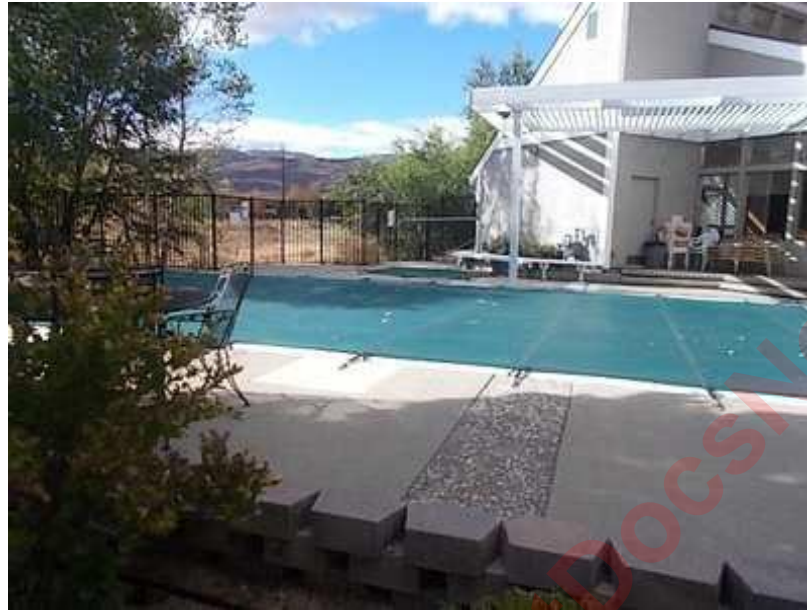
Component	Year Scheduled	Units	Cost Per Unit	Today's Cost	Estimated Remaining Useful Life (Years)	Estimated Life When New (Years)
Pool Area - Pool Deck Replacement	2027	all	22000.00	22000.00	10	30
Pool Area - Pool Filter	2021	ea	1500.00	1500.00	4	5
Pool Area - Pool Furniture	2019	all	2000.00	2000.00	2	5
Pool Area - Pool Heater	2022	1 unit	5000.00	5000.00	5	40
Pool Area - Pool Pump	2019	1 unit	1500.00	1500.00	2	3
Pool Area - Pool Resurface	2025	1 unit	8000.00	8000.00	8	10
Pool Area - Shade Structures Replacement	2027	1 unit	6000.00	6000.00	10	20
Pool Area - Spa Filter	2021	1 unit	1500.00	1500.00	4	5
Pool Area - Spa Heater	2021	1 unit	5000.00	5000.00	4	7
Pool Area - Spa Pump	2019	1 unit	1500.00	1500.00	2	3
Pool Area - Spa Resurface	2022	1 unit	6000.00	6000.00	5	7
Pool Area - Wrought Iron Fence Replacement	2027	all	9500.00	9500.00	10	20

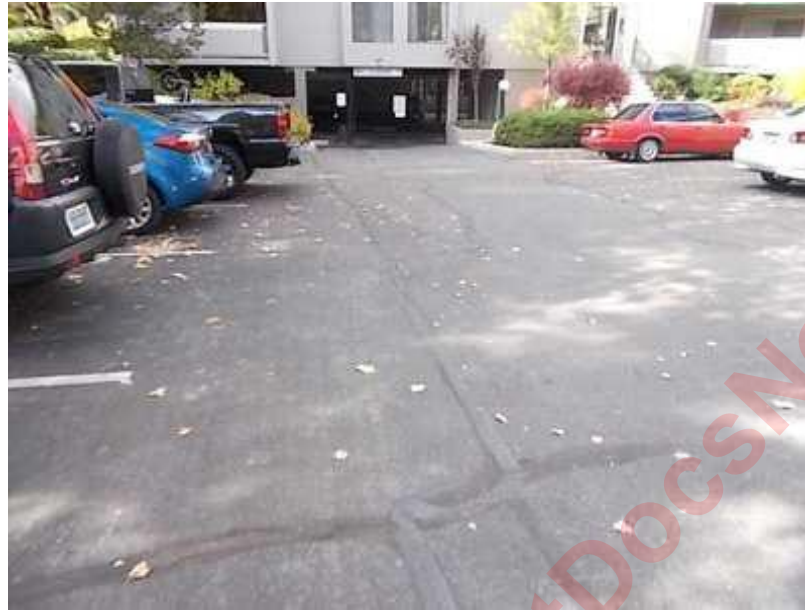
Component	Year Scheduled	Units	Cost Per Unit	Today's Cost	Estimated Remaining Useful Life (Years)	Estimated Life When New (Years)
Roads and Parking - Concrete Curb Gutters Replacement Contingency	2026	as needed	10000.00	10000.00	9	10
Roads and Parking - Concrete to Asphalt Joint Sealing	2019	1 unit	4500.00	4500.00	2	4
Roads and Parking - Crack Seal	2018	as needed	2500.00	2500.00	1	2
Roads and Parking - Overlay	2027	29500 sq ft	1.50/sq ft	44250.00	10	30
Roads and Parking - Striping and Curb Painting	2018	all	2500.00	2500.00	1	5
Roads and Parking - Surface Maintenance Treatment	2017	29500 sq ft	0.25/sq ft	7375.00	0	5
